# **ENVIRONMENTAL MANAGEMENT REPORT**

July 2008 to  
December 2011

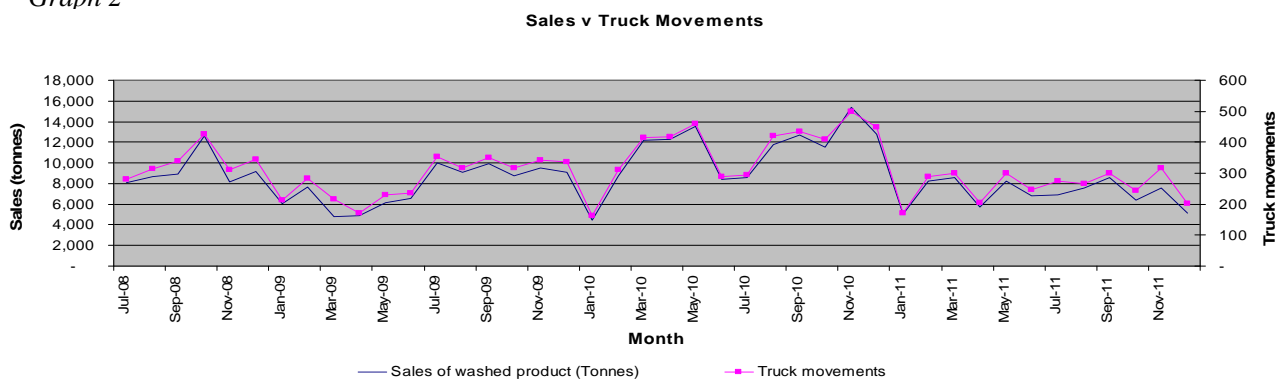
Actual truck movements during the reporting period totalled 13,064 which equates to an average of 17 loads per work day. This is significantly less than the average predicted in the EIS of 24 loads per day (in 1999) increasing at an annual rate of 2% (ie anticipated 31 loads per day in 2012). Graph 2 below shows the correlation between sand sales and truck movement during the reporting period.

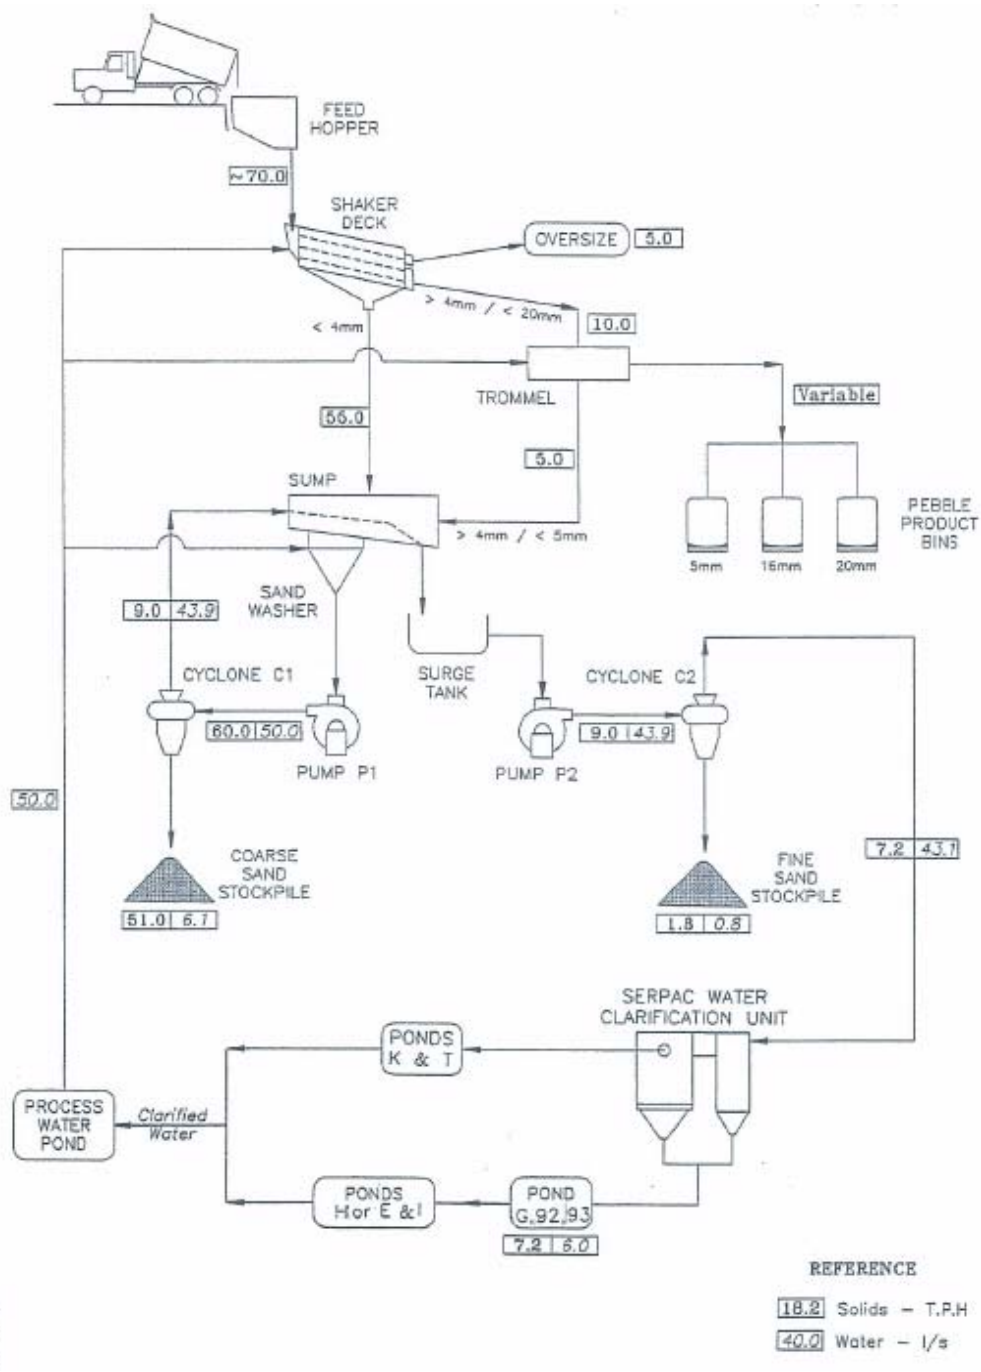
Diagram 3 – Wet Processing Plant

Water is supplied to individual functions of the wet processing plant including the shaker deck, trommel and sand washer. Water used in the sand washing function is first used for extraction of coarse sand and then the recovery of fine sands. Cyclones are used at each stage of sand extraction for dewatering and removal of fines.

The wet processing plant has a constant demand for water when in operation of 3,400 litres per tonne of washed product or 50 litres per second. Given approximately 25% of the water used in the process is lost either by evaporation, retained in waste products (ie silt) or retained in the washed sand, it is important to harvest and recycle water on site.

A schematic showing the wet processing plant functions has been provided in Diagram 3 below:

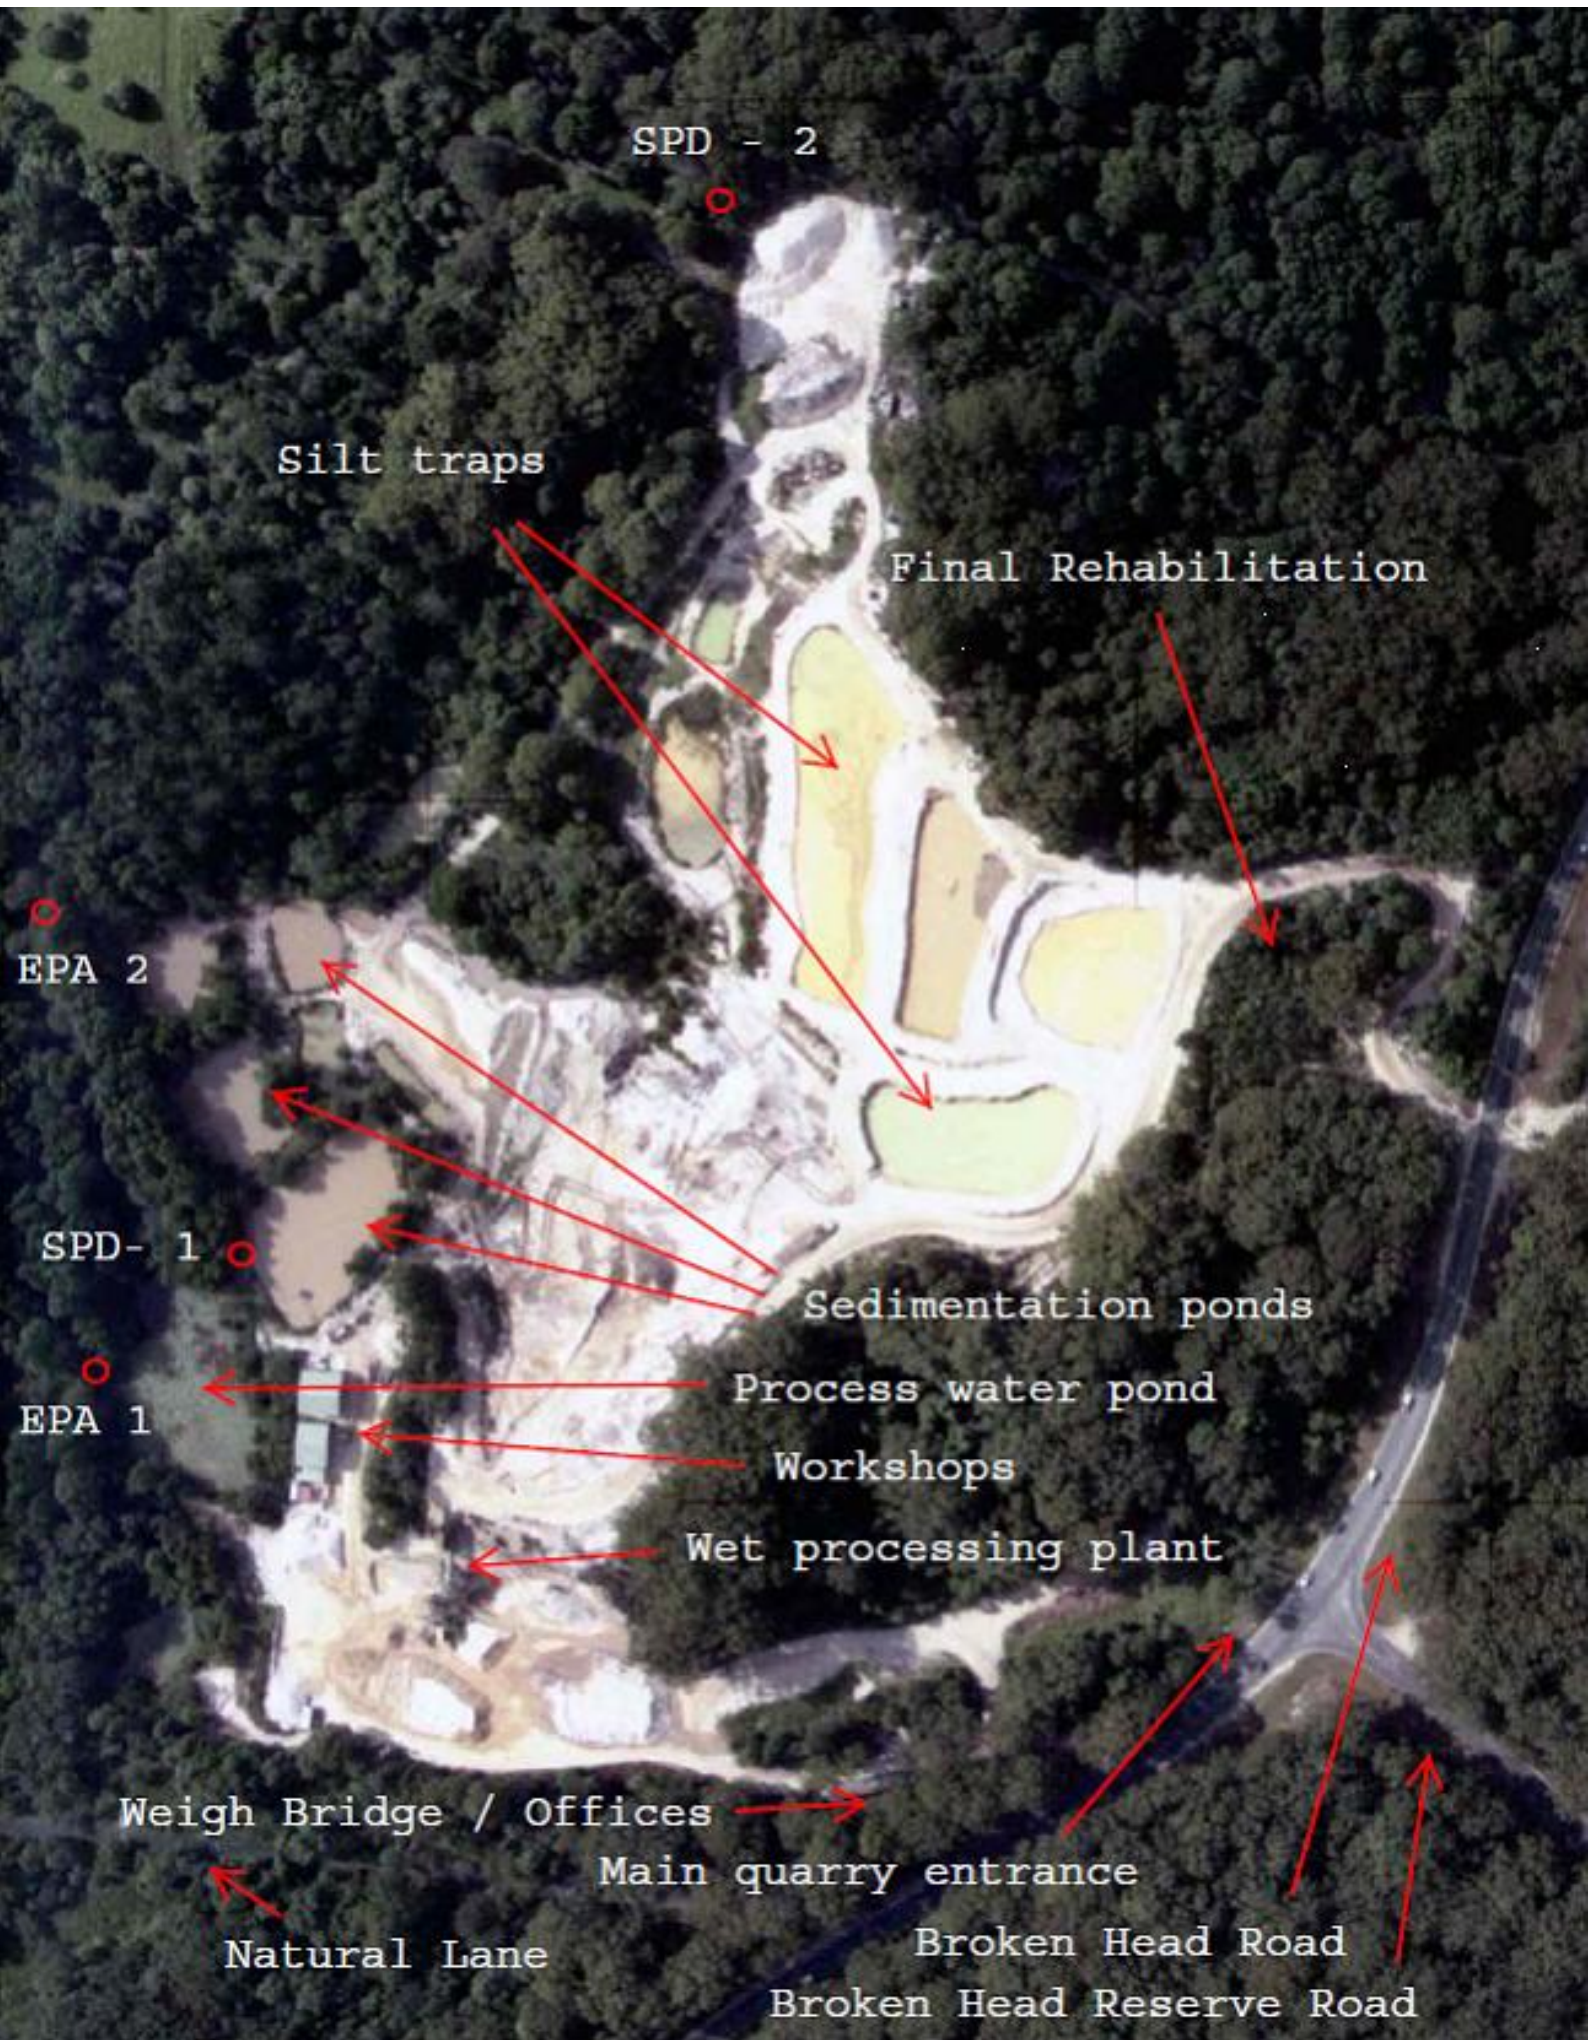
SPD - 2

Silt traps

EPA 2

SPD- 1

Sedimentation ponds

EPA 1

Monitoring and testing is completed on every occasion water is discharged from the site as required under the EPL. These water samples are obtained at two dedicated monitoring / discharge points known as EPA 1 and EPA 2 and submitted for independent testing. These points are shown on the site map included further in this report.

Dust sampling continues to be undertaken at four separate locations on site. These locations are shown on the site map included in this report and marked as SPD 1, SPD 2, SPD 3 and SPD 4 and also represented by the red squares in Diagram 3 below.

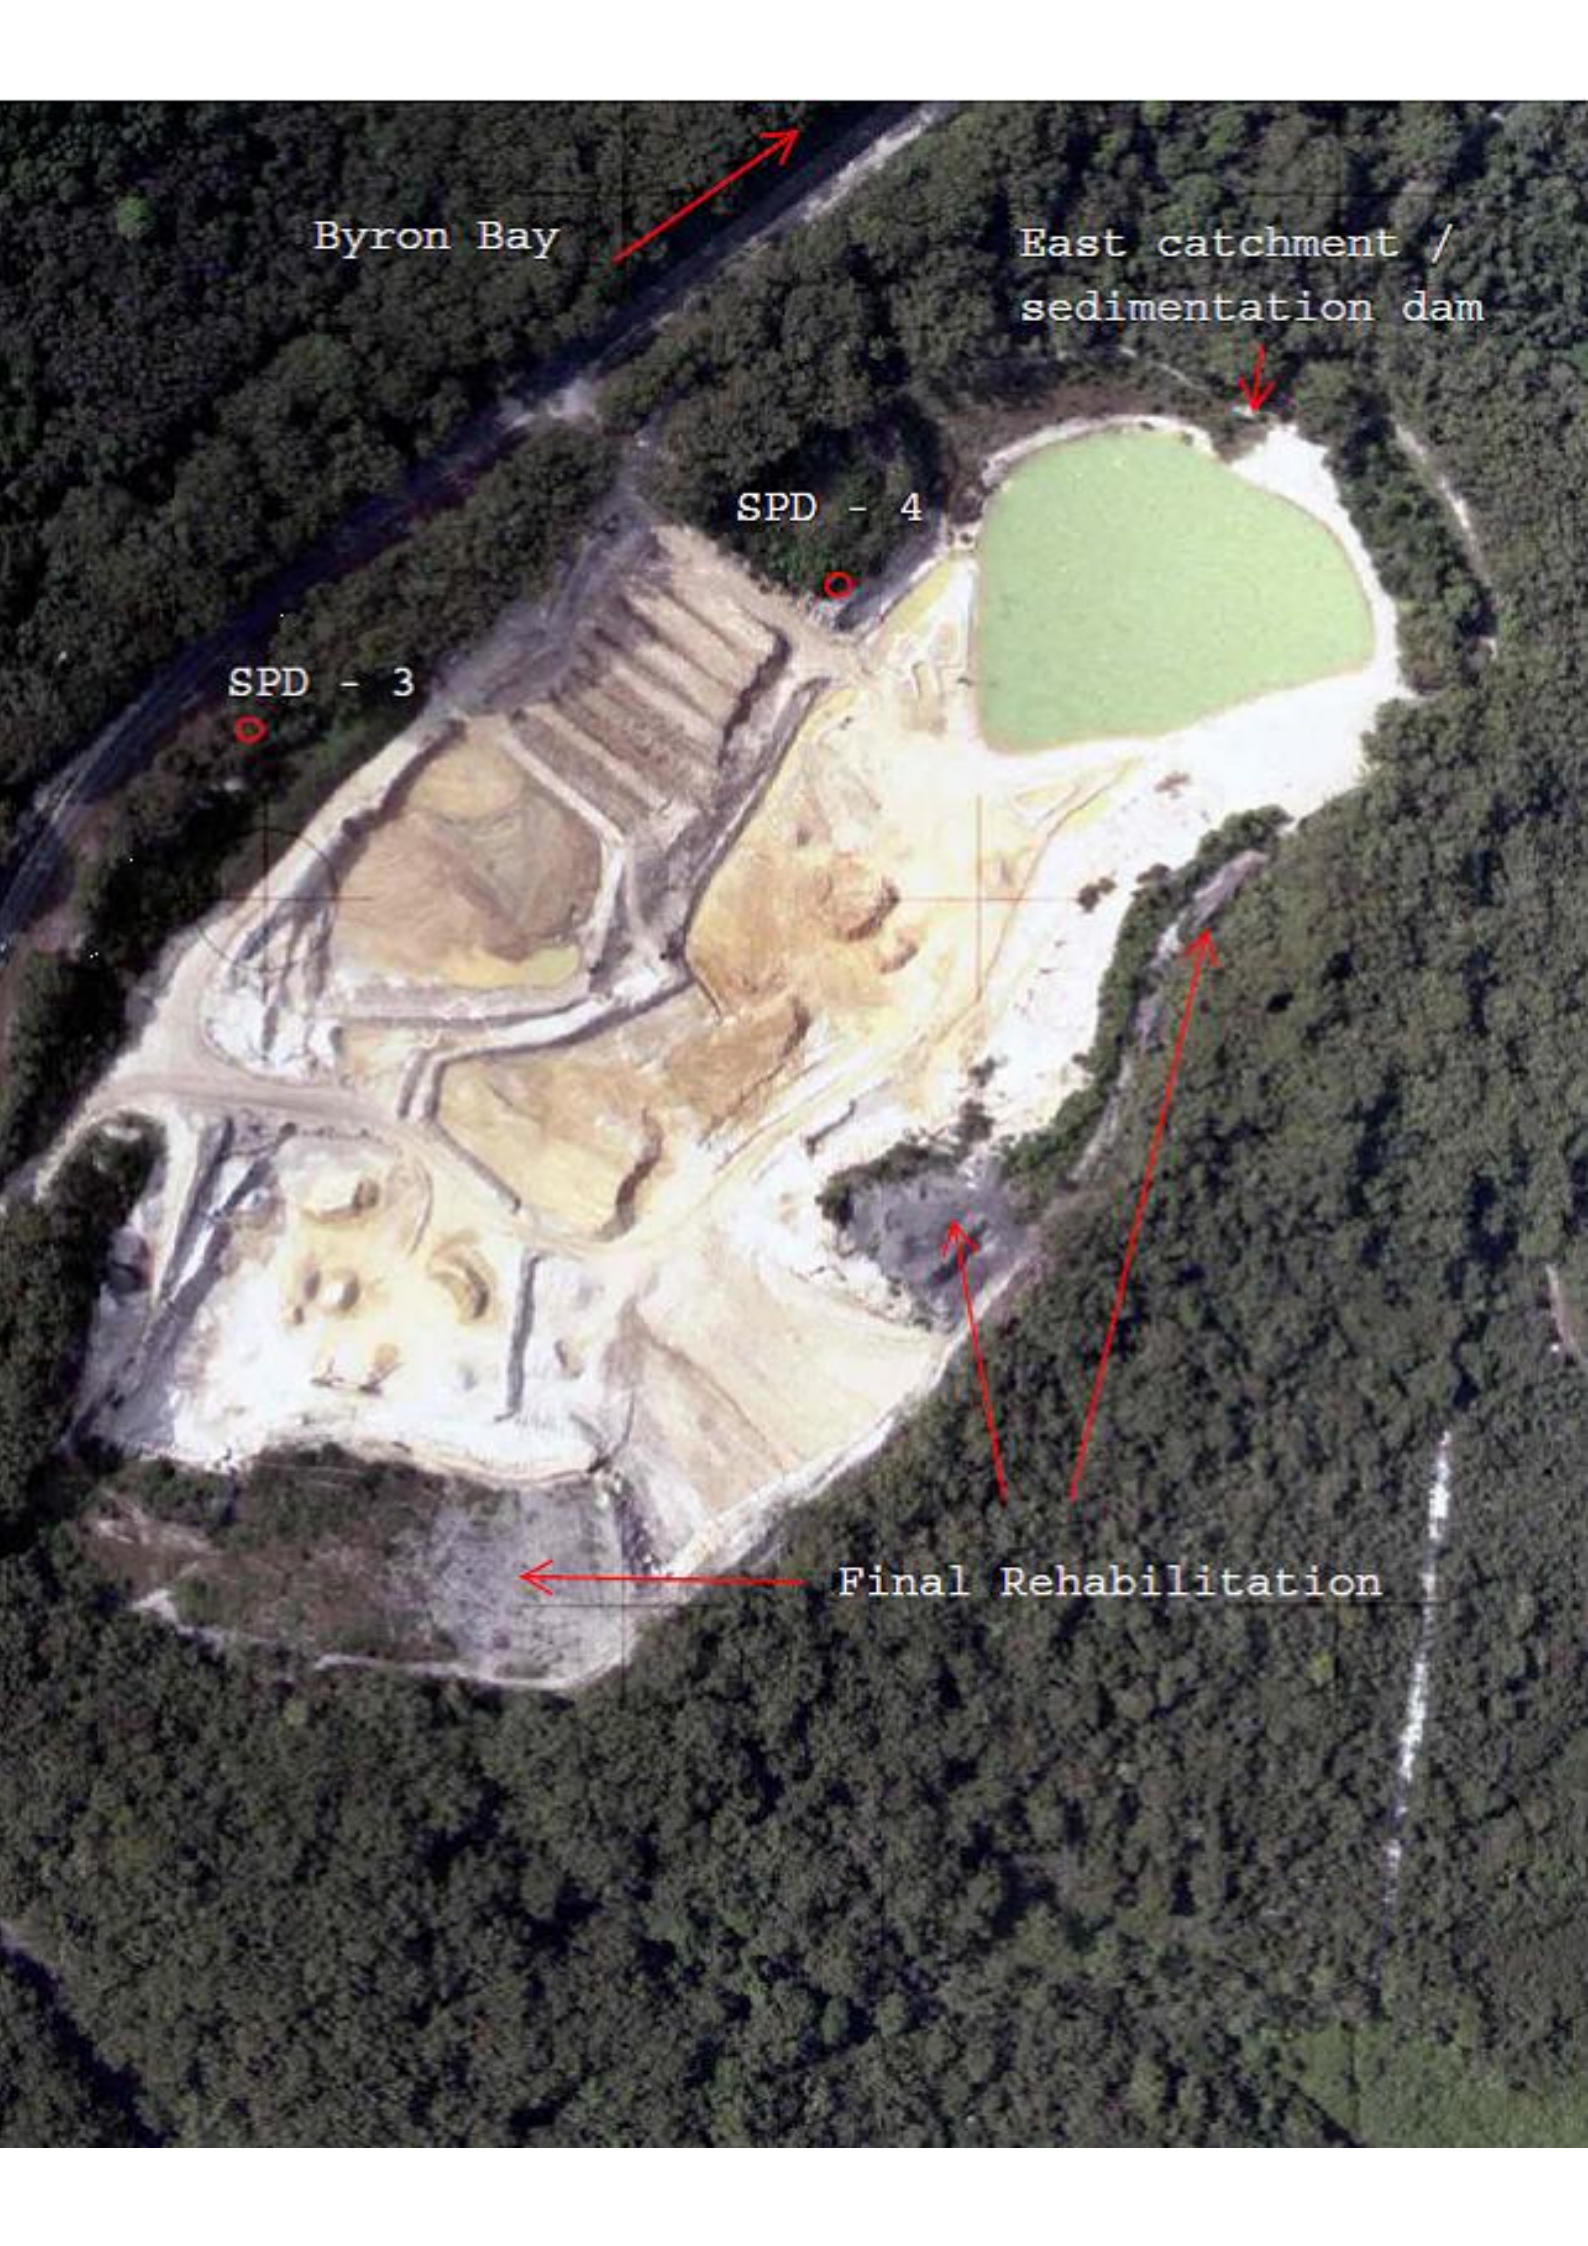
East catchment /  
sedimentation dam

Where relevant, this report seeks to maintain the reporting format of previous reports and references the site map contained in the report. It should be noted that this map is included to highlight particularly areas and functions on the site only and should not be viewed as representing a current aerial photograph.

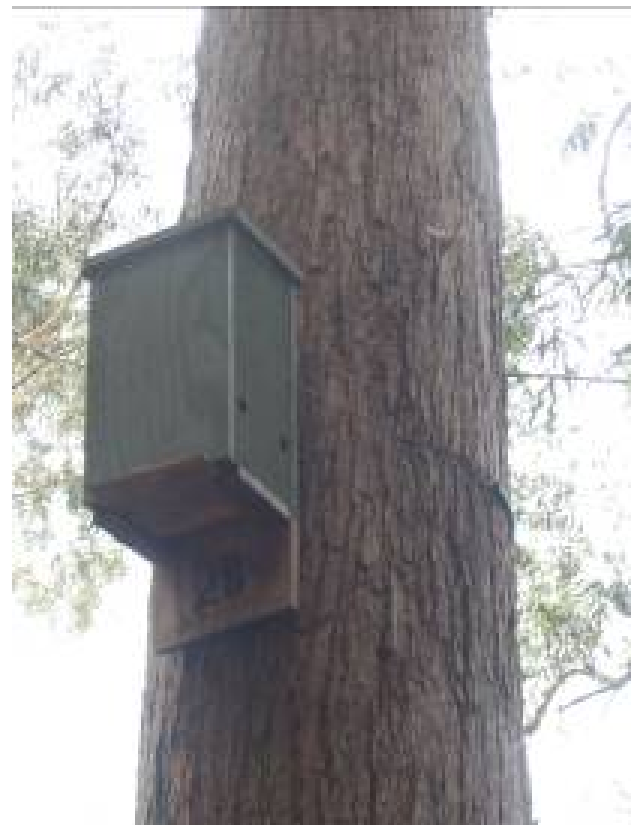
*Example of Fauna nest box*

- Additional habitat for native hollow-dwelling fauna provided including eleven fauna nest boxes;
- Significant growth of native species throughout rehabilitated areas and dense growth of shrub species particularly around east catchment / sedimentation dam;
- Additional seedlings have been planted and have become well established while prior planting show signs of continued growth;
- Alterations to planting strategy including adding water crystals, time of planting, fertilising and mulching has increased the survival rate of plantings;
- Seed collection continues to be undertaken and the nursery has continued to produce a variety of trees, groundcovers, shrubs and sedges for planting in rehabilitated areas;
- Local off-site seed collection has been adopted to complement on-site collections in order to maintain adequate stock levels of seedlings;

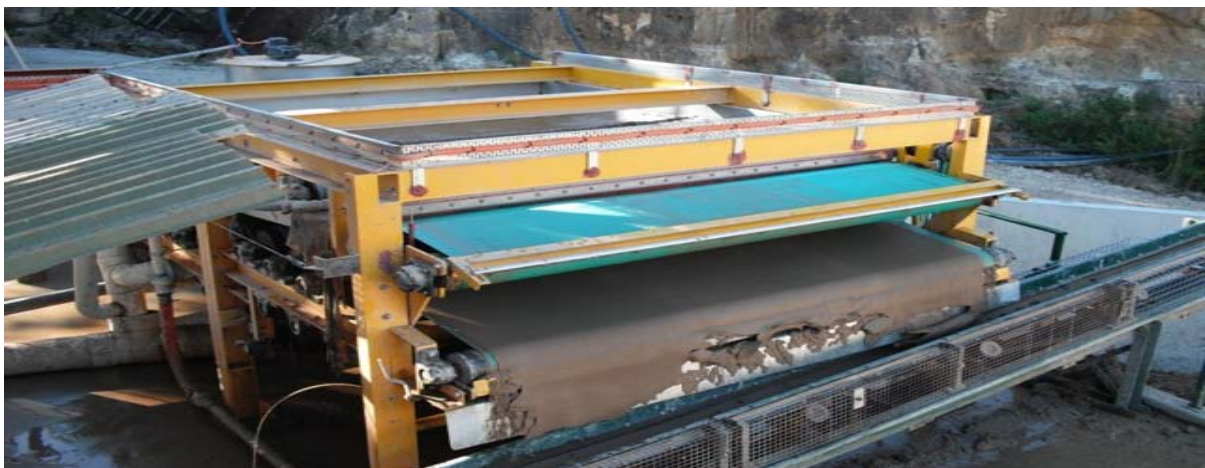
#### *Silt press*

More recently however the quarry has acquired a silt press specifically designed for processing sand. The two main features of the silt press are firstly to facilitate efficient water recycling at the point of production ie extract more ‘clean’ water before waste leaves the wet processing plant and secondly to speed up the drying time of silt prior to transporting and use in rehabilitation.

Whilst the silt press is being commissioned and tested, the quarry utilises eco-friendly silt bags as an interim silt management solution. Silt bags are considered to be the most efficient and environmentally sound method of silt management however the unit cost and single use of each bag makes them a prohibitive long term silt management solution.

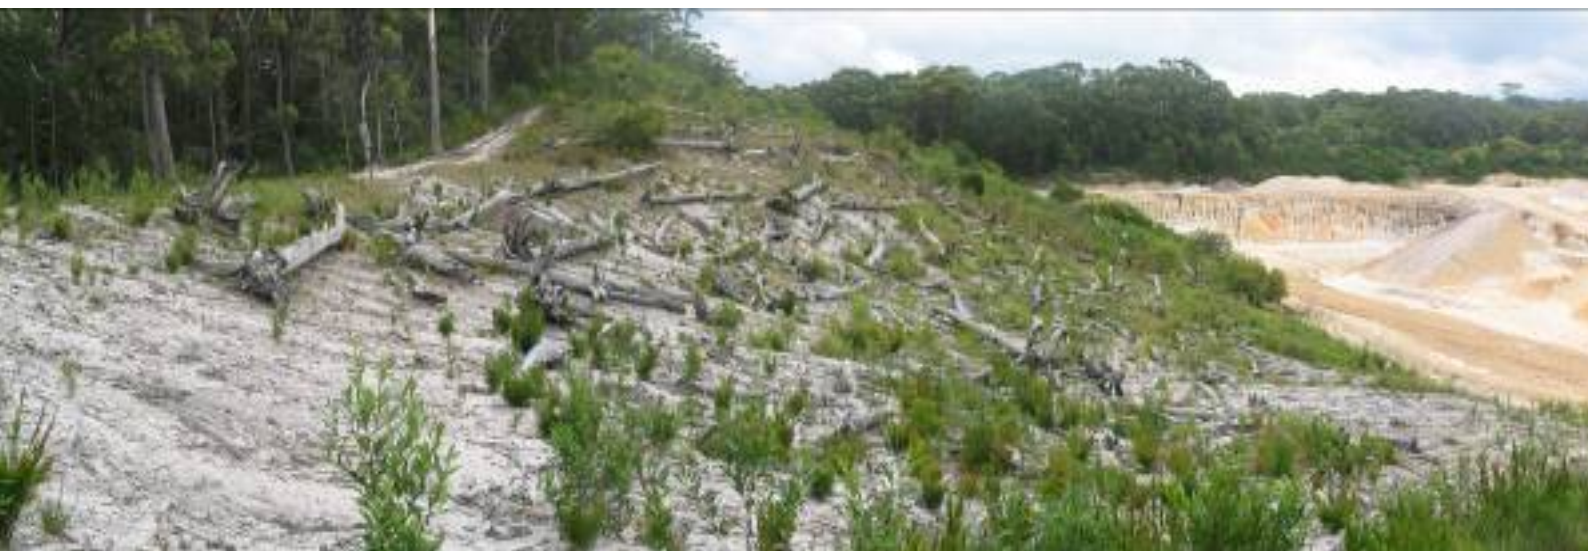
*Final rehabilitation on east side (RE3)*

The rehabilitated areas are prepared as recommended with low slope drainage networks that incorporate logs, brush and other vegetation litter in the topsoil. This ensures the impact of raindrops on the surface is reduced, assists rainfall infiltration, reduces run-off velocity, minimises dust and aids seed retention
